TEST REPORT

Report No: SZ160510378R1EN Report Date: 2016/05/26

Sample Name Nylon plastic granules
Material AKV30FN00, A30FN31

1. PHTHALATES CONTENT

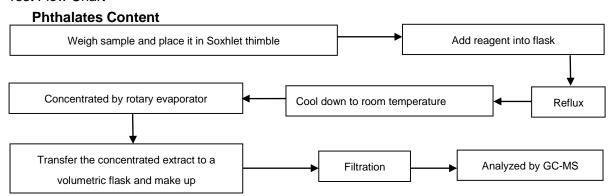
Test Flow Chart

With reference to EN 14372:2004, and analyzed by Gas Chromatography and Mass Spectrometry (GC-MS).

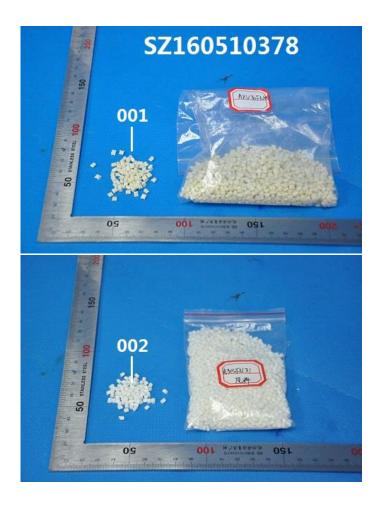
Photo(s) of the sample(s)

| Sample | Tested Material Description |
|---|---|
| 001 | Beige plastic granules |
| 002 | White plastic granules |
